News

Issue 6 Summer 2020

HBSS 4253 Boiler Progress Report

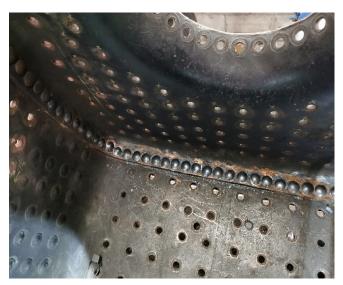
The lap seam rivets seen here from the outside, before the new top section of the backhead was riveted on. Note the boiler and firebox stays that keep everything together when under 200 lbs pressure! The crown stays have been removed for renewal.

As you can see in the pictures, the top section of the backhead has now been riveted in position (bearing in mind the boiler is, as usual, upside down). With the old top section off, it gave a rare opportunity for the firebox lap seam to be reriveted, which you can see in the photos below.

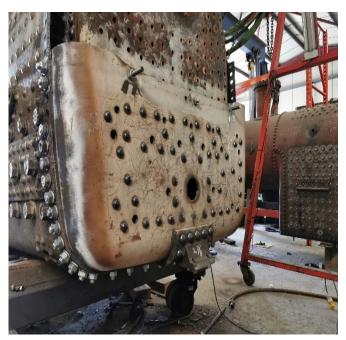
A nice new row of lap seam rivets seen from the inside of the firebox. The holes in the lower part of the picture are where the new crown stays will be bolted.

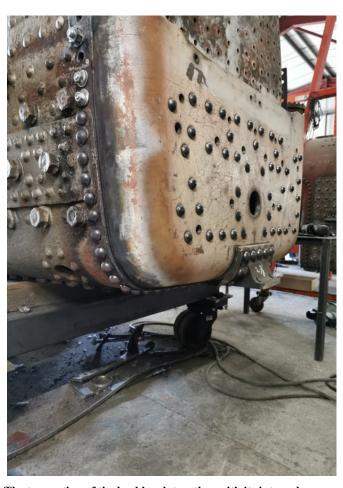
This picture shows the top section of the backhead positioned and bolted up ready for riveting. Note the steam manifold mounting pad, bottom centre, which has now been riveted in position. This mounting plate carries steam to all gauges and controls in the cab.

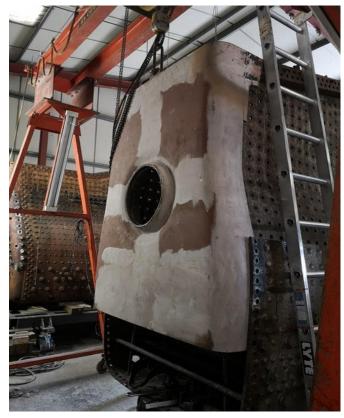
The top section of the backhead, together with its internal strengthening doubling plate, is now riveted in position. The remaining temporary fixing bolts at the top are awaiting the lower backhead section and boiler side wrappers to be positioned and drilled, before further riveting takes place.
