Newsletter

Issue 17

Spring 2022

The 4253 Locomotive Company Limited, based in Rolvenden, Kent, is a non-profit, non-political organisation. Reproduction of photos by permission of The 4253 Locomotive Company.

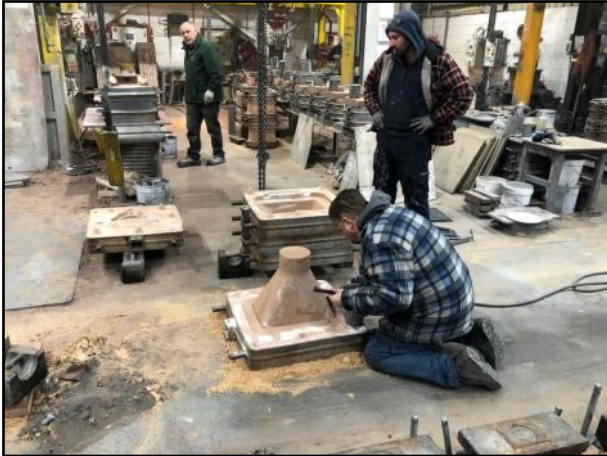
The inner pattern is made ready to accept the outer pattern.

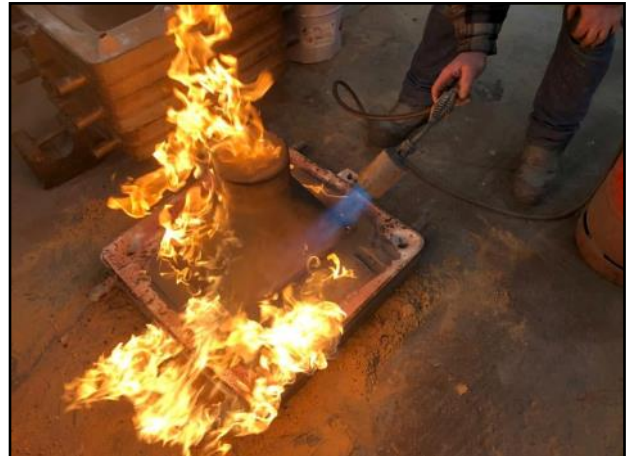
Go easy with that gas!!!

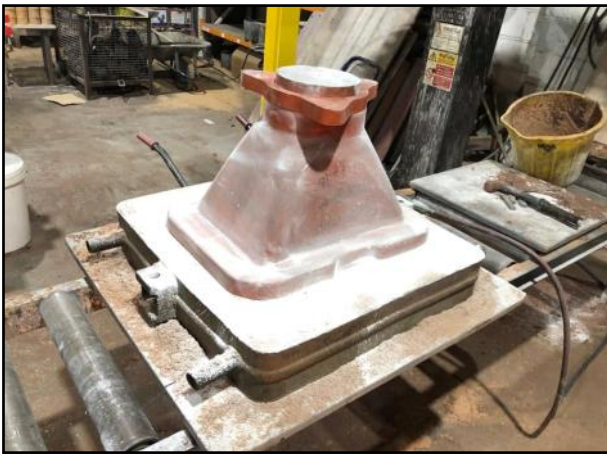
The outer pattern is positioned on top of the inner pattern to create the void for the molten metal.

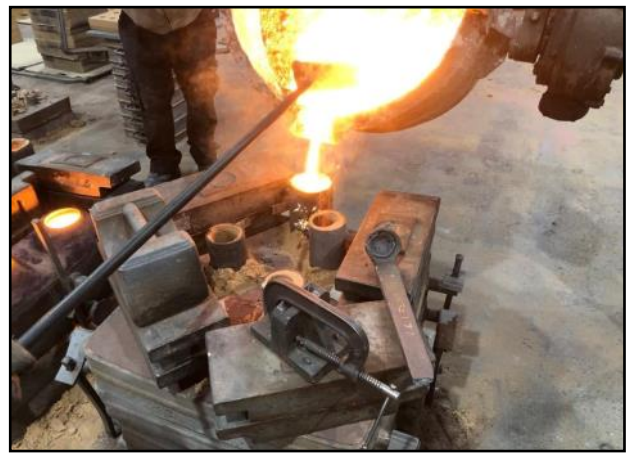
Pouring the molten metal into the mould.

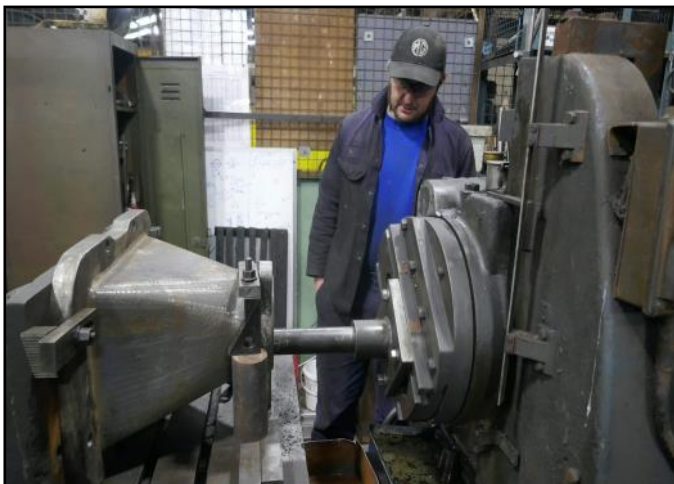
The finished casting back at Rolvenden works. Henry is seen here boring out the opening to the correct diameter.

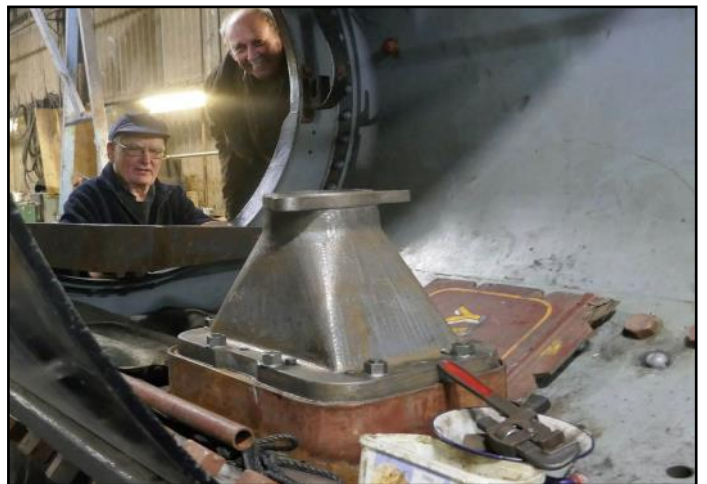
The blast pipe fitted in the smoke box . . . Chris and Dick are looking into it.

As if the recent costs of two new rods, boiler and everything else were not enough, another item that we've had to have remanufactured was the blast pipe. The blast pipe sits immediately under the chimney in the smoke box and directs used steam from the cylinders up through the chimney. The original blast pipe was found to be fairly wasted by heat, steam and rust over many years of use. Many thanks to Maybrey Foundry, Maidstone for the following pictures, which show them casting our new blast pipe. Also, luckily, the West Somerset Railway had a wooden blast pipe pattern which they loaned to us for the casting. We send many thanks to both companies.

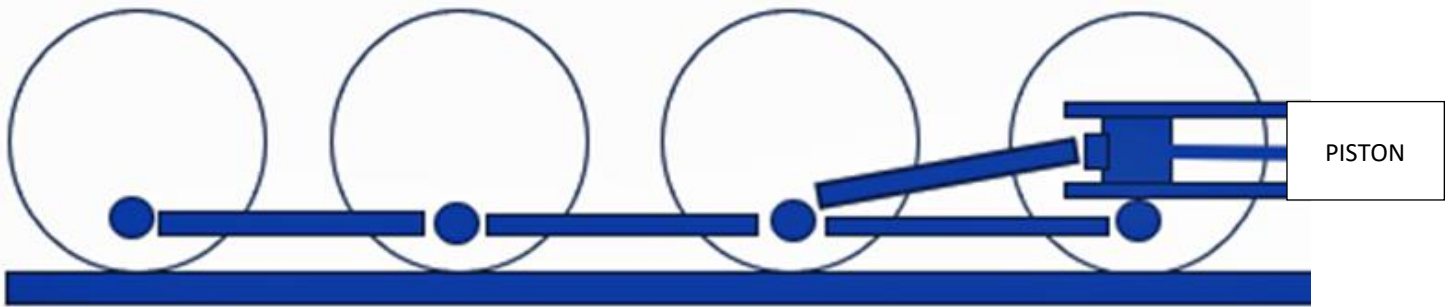
This simple diagram shows the rod configuration for 4253 which as you know is a 2-8-0 locomotive, with the important number being the 8, the 4 power axles (consisting of 8 wheels).

On each side of the locomotive, all four axles are connected by 3 coupling rods. The second axle from the front of the locomotive also has a connecting rod, which attaches to the 'crosshead'. I am sure you have seen a photo of this in other reports and on our Facebook page. The crosshead is connected to the pistons and slides back and forth with the force of the pistons, and just like a piston in a combustion engine, converts the piston's reciprocating movement into rotary movement to drive the axles, via the coupling rods.

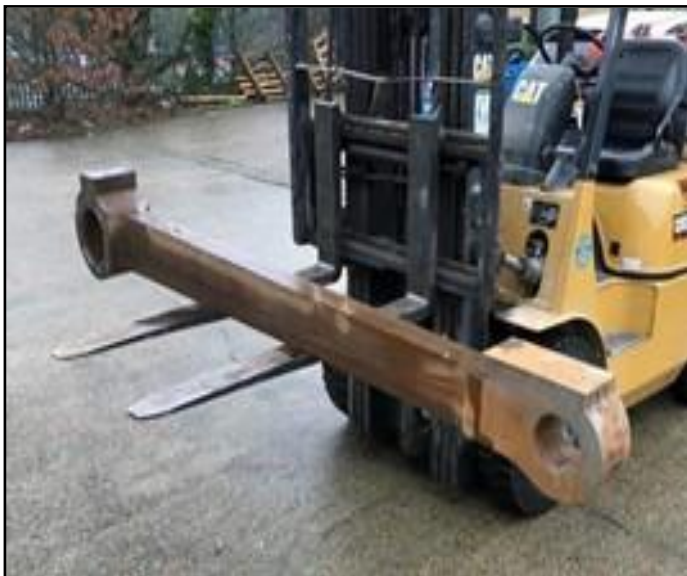
Basic water jet cut completed at SCISS before moving on to the machining stage.

The forgings were water jet cut to basic shape by SCISS Ltd in Staplehurst, and then taken to Automation Technologies Ltd, who are based in Brede, East Sussex for final machining. The intermediate rod has been finished and is back at Rolvenden while work on the connecting rod will begin shortly.

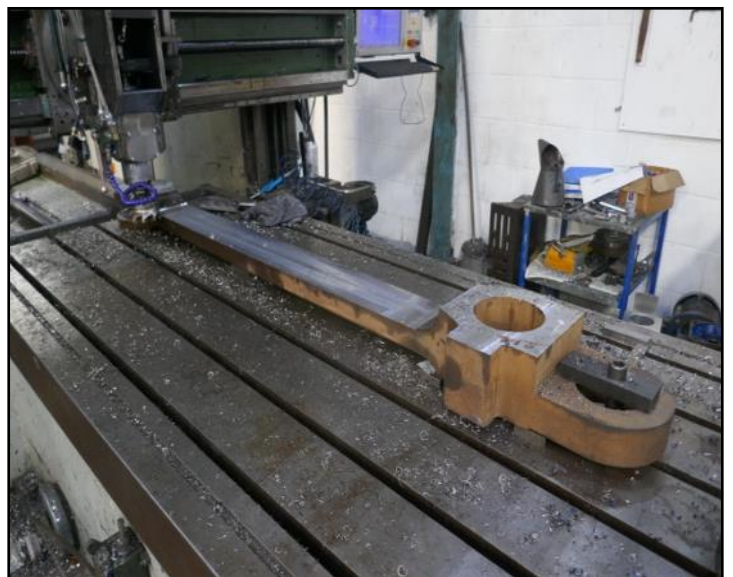
One of the first cuts from the computer controlled machine at Automation Technologies, Brede, East Sussex.

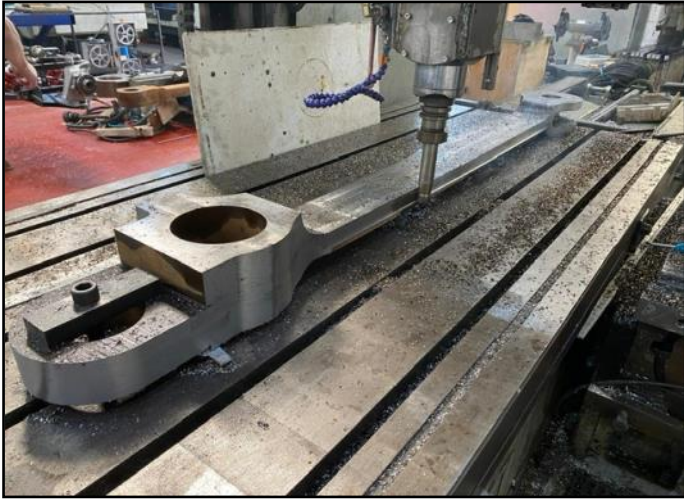
Finishing in progress.

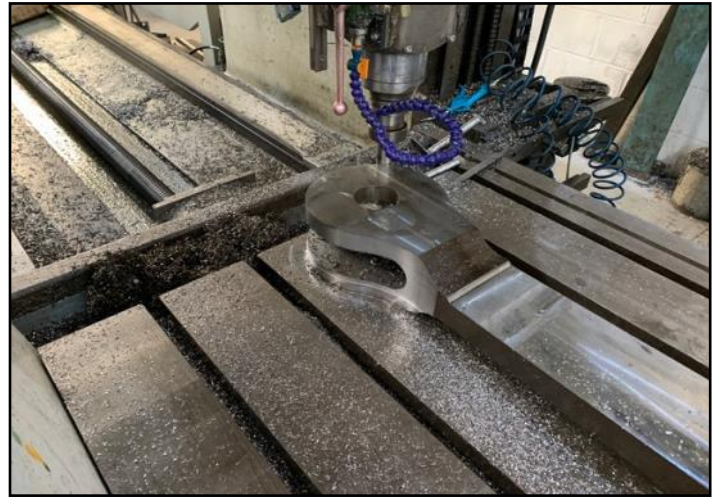
Shaping the curved end of the coupling rod.

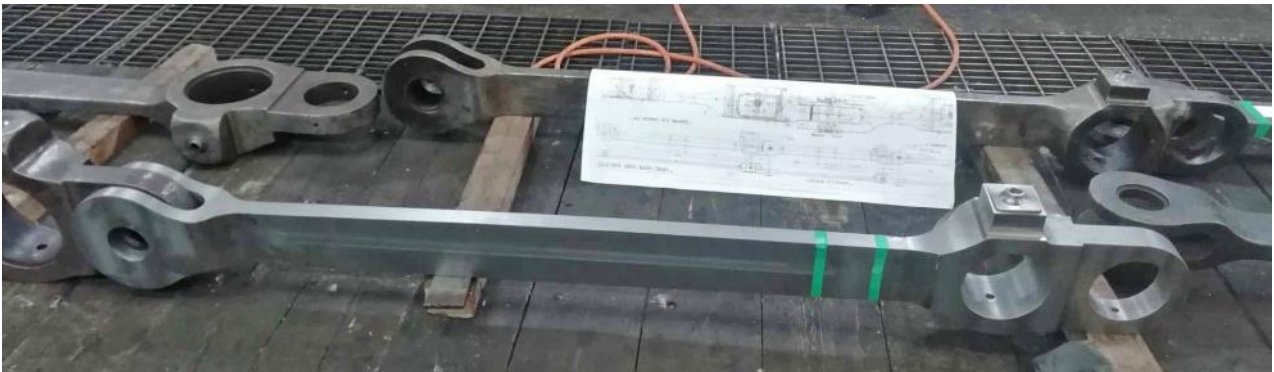
Finished intermediate rod at Rolvenden

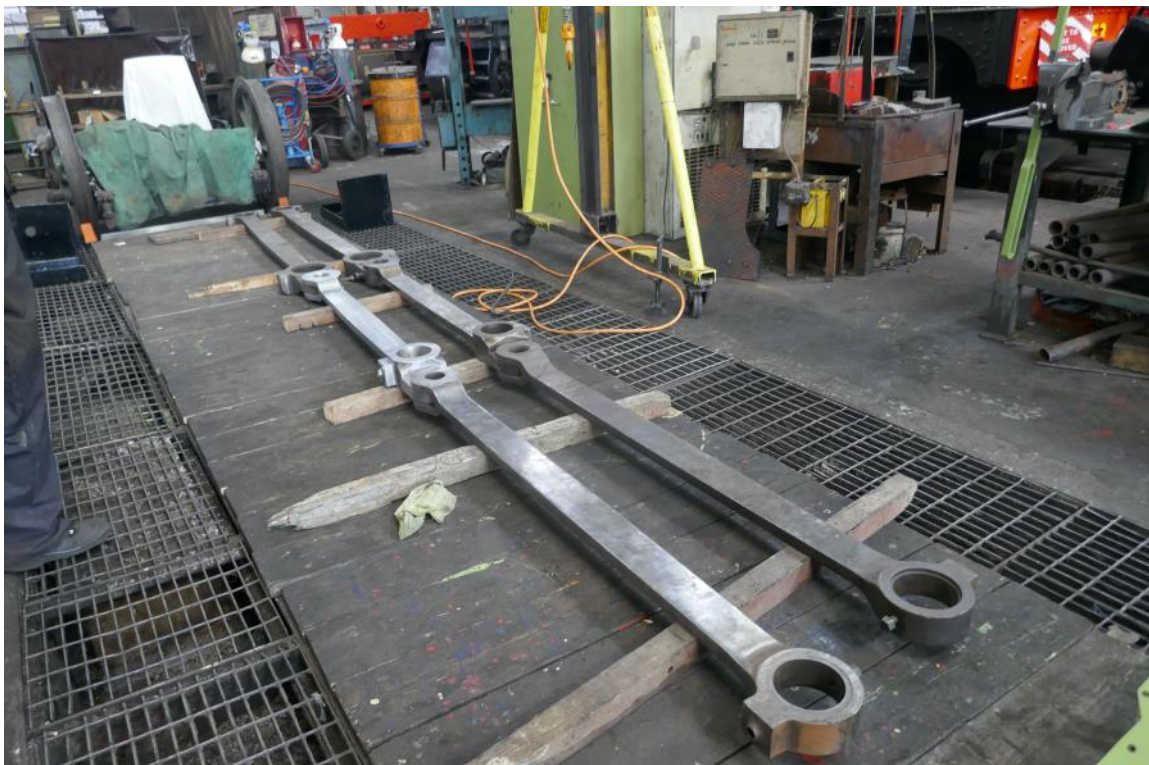
Full set of coupling rods

Accordingly, we now have a full set of coupling rods laid out and measuring has begun for machining the various bearings and pins.

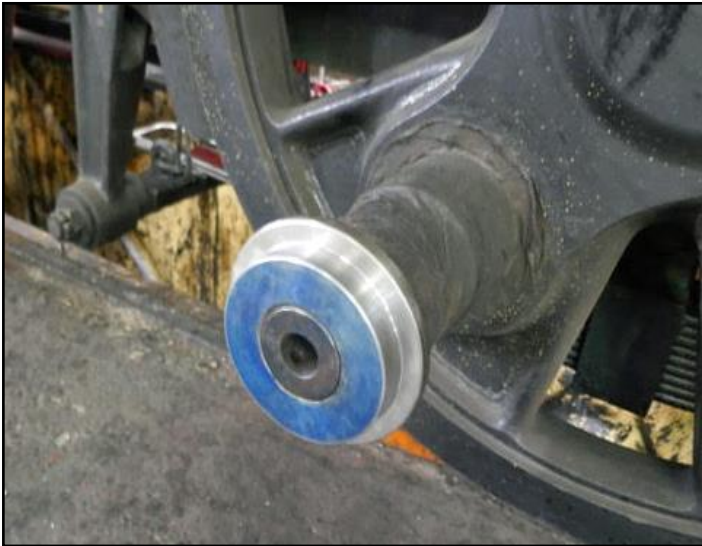
Test fitting prior to cutting.

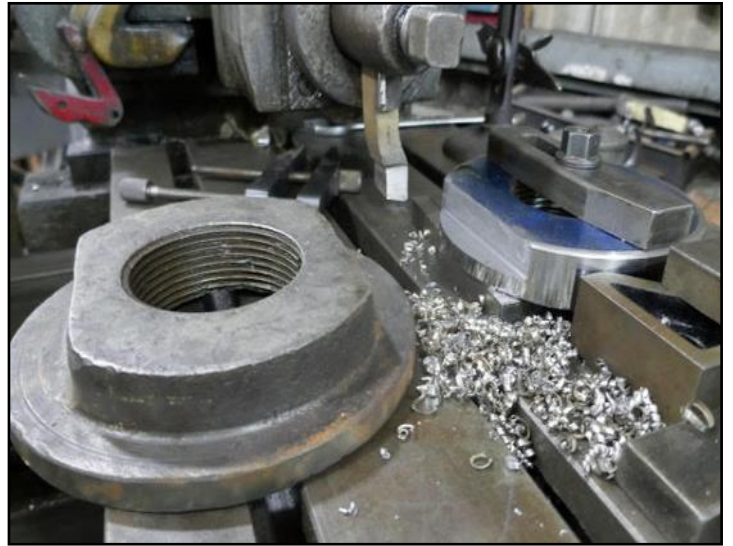
Old nut with new one being made.

As well as the two rods being manufactured, there are also the nuts to hold the rods onto the wheel crankpins, plus the brass bushes with white metal linings that go into the holes which have been cut into the rods that will allow the wheel crankpins to rotate within the holes.

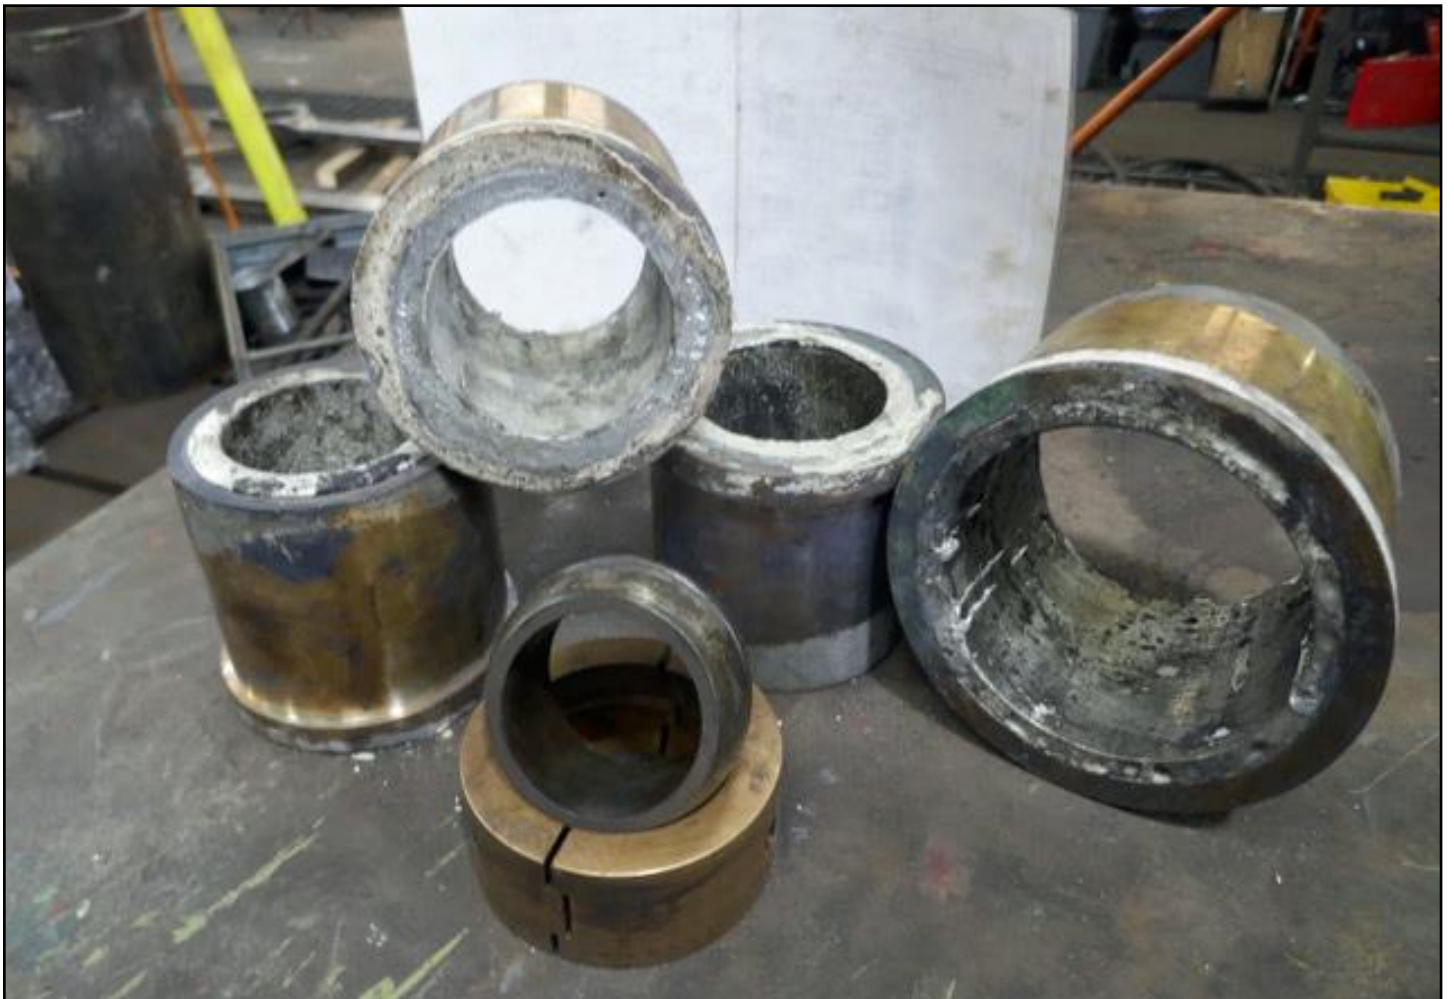
A selection of bushes needed, which have been white metalled ready for final machining and fitting.

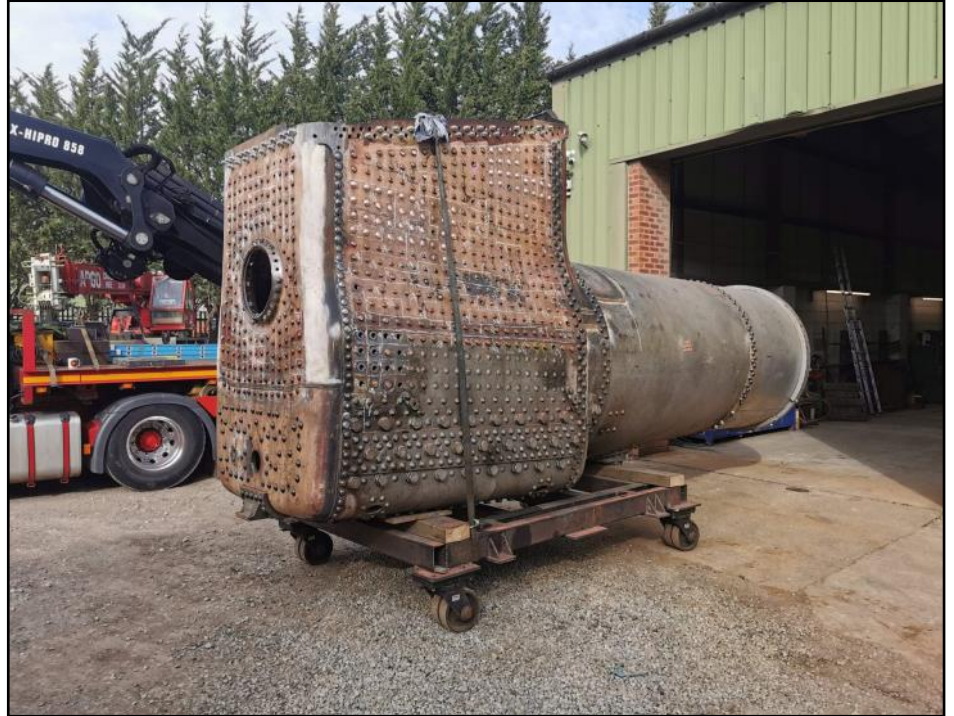
With most of the stays now in place and all 'knocked over', the next and final step is to cut out and renew the crown stays, which are at the top of the boiler. So, with the boiler having been upside down for many years, it needed to be placed on its side for ease of access. The picture (right) shows the boiler briefly out in the daylight ready for lowering onto its side. It certainly gives a good idea of the hundreds of

The boiler comes out for an hour or two into the daylight. All looking good.

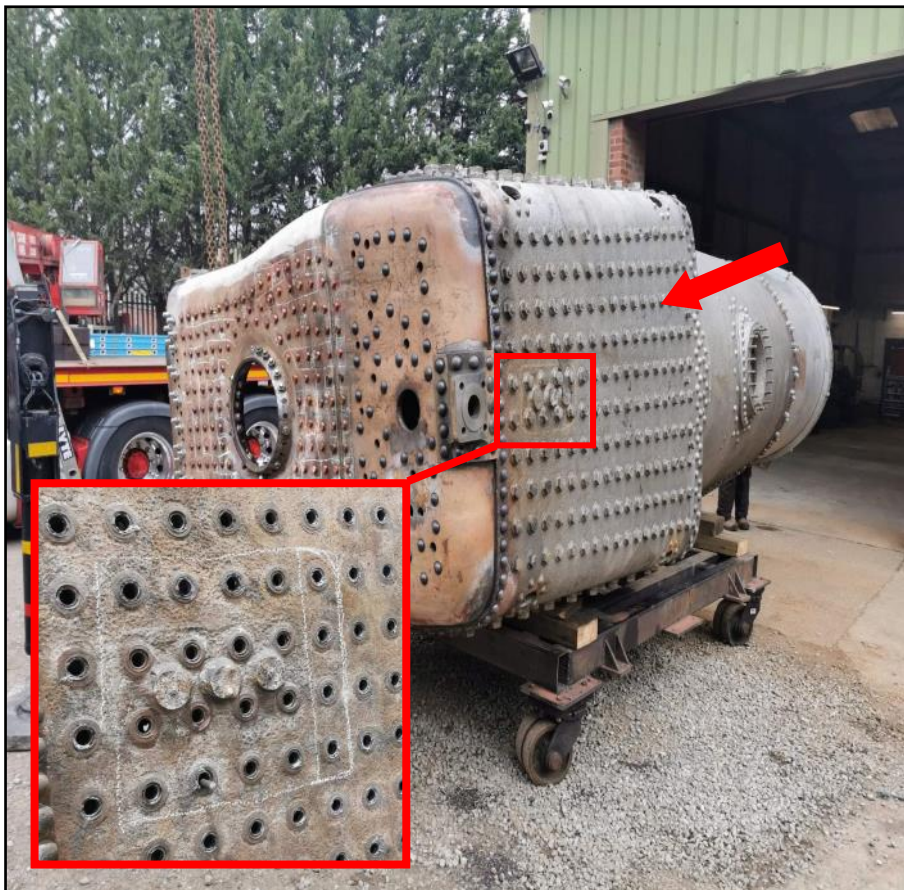
The discovery of another area that needs attention. Hopefully the last!

The red arrow (left) indicates the many rows of crown stays that have now been 'blown out' with a torch and which are awaiting replacement.

The red squares show a close up of an area where the boiler plate has now been cut out and is in the process of being replaced (see following page), which is immediately under the whistle. Due to wasting of the metal over many years it was less than the minimum thickness permitted.

Given that our working boiler would have been clad in thick insulation and with perhaps a leaking whistle, water has possibly been trapped in this area which has accelerated rusting.

Work on the boiler is progressing well and, with the majority of the copper stays now fitted and tooled, it has been turned on its side to provide access for fitting the new crown stays. Unfortunately, with the top of the boiler now fully exposed, HBSS are concerned with one area of plate that shows evidence of wasting; probably as a result of a dripping whistle. So, in addition to the reassembly costs, we will now need to cover the cost of inserting a repair patch.

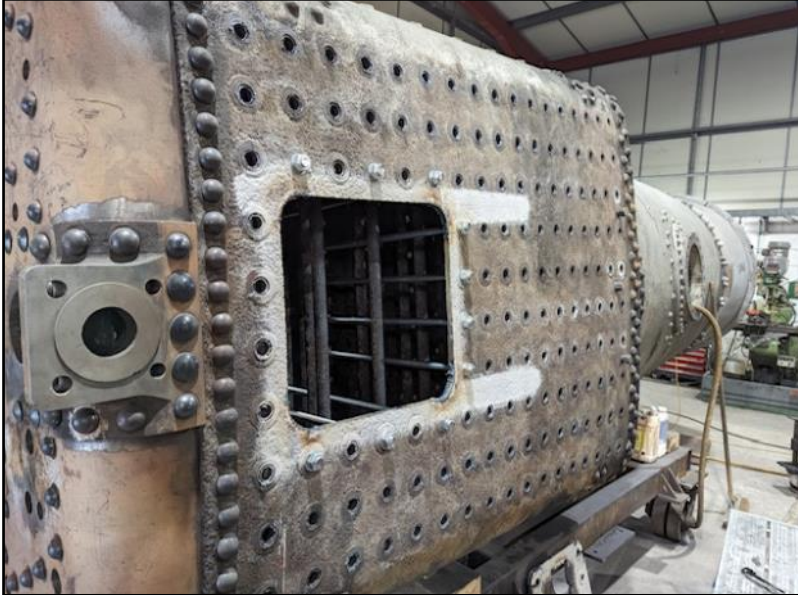
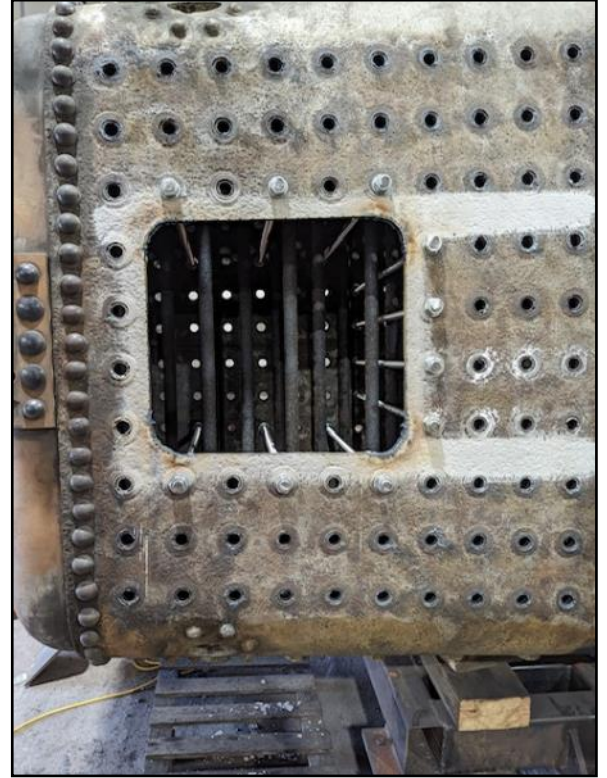
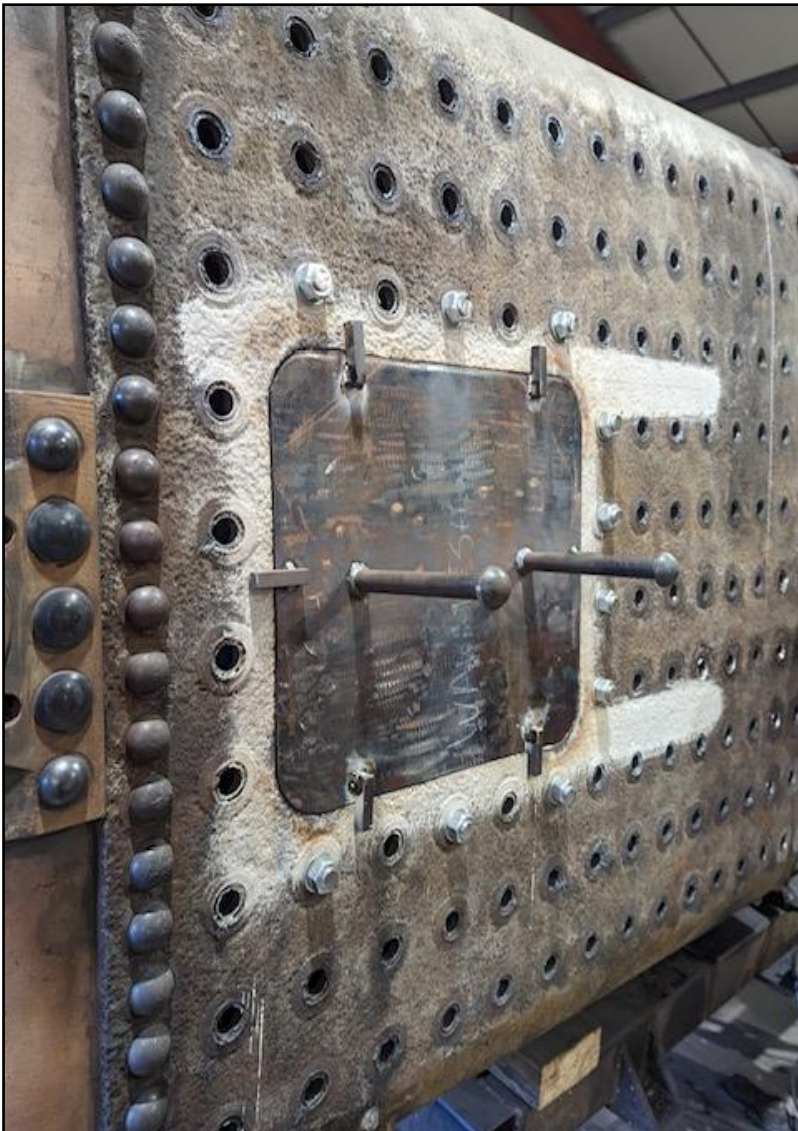
These photos show the area now cut out ready for the new crown insert to be welded in. This also gives an opportunity to look inside and see the complicated criss-cross of stays that keep the firebox and outer boiler plate in place and which provide enormous strength to this area.

As you can see, all the other old crown stays have now been removed and the threaded holes will soon be prepared to take the new stays.

The picture on the left shows the new plate ready to be secured in position using 'coded' welding. This will ensure it passes the boiler inspector's inspection. Attached to the new plate are temporary fixings to hold it in place before welding begins. It will then need to be drilled to take the new crown stays.

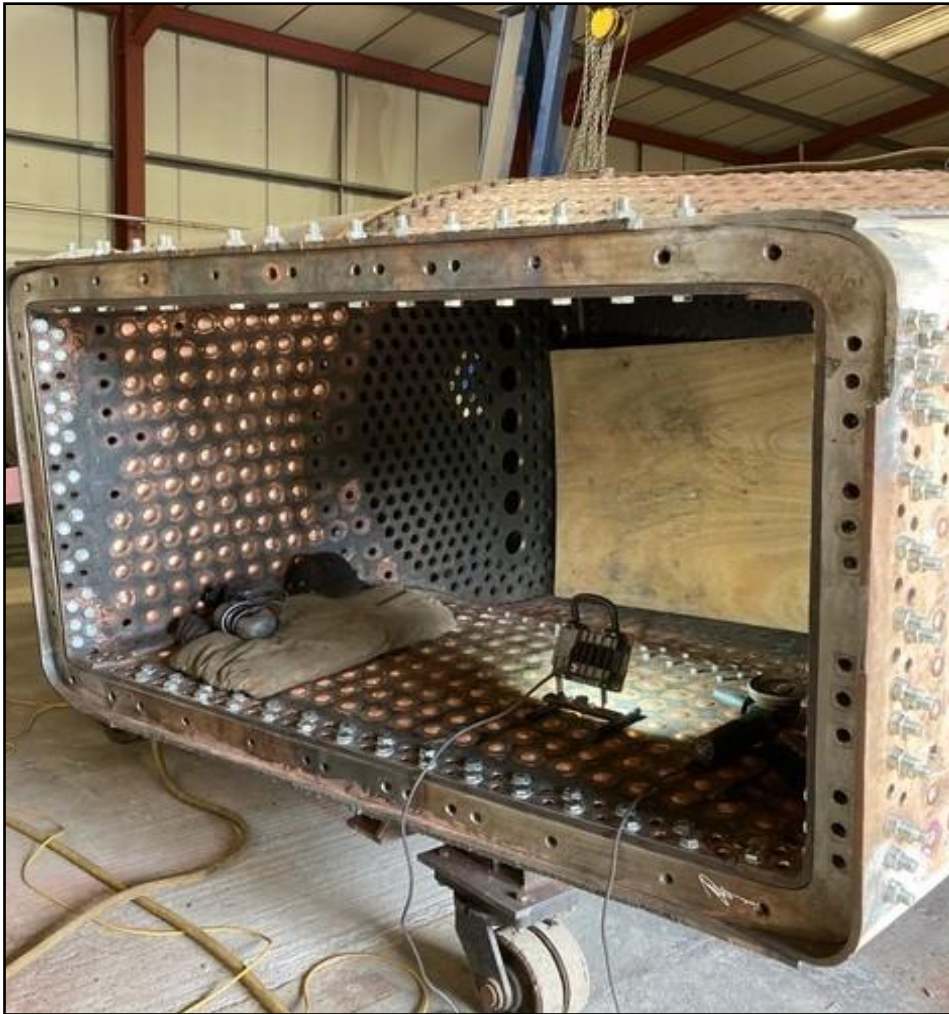
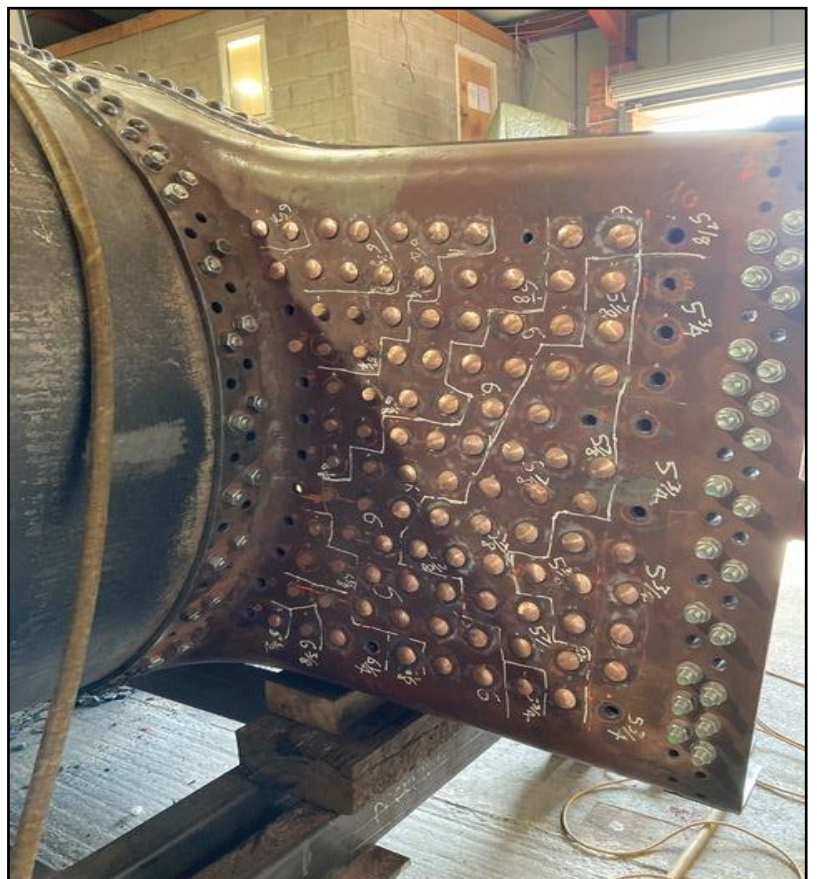
Meanwhile, at the other end of the boiler, these pictures show the foundation ring (*left*) and throat plate (*below*) on their side ready for the final rivets.

At the front of the firebox, the throatplate is shown here requiring just a few more copper stays to complete the job. As you can see, there has been much marking and measuring by the guys at HBSS.

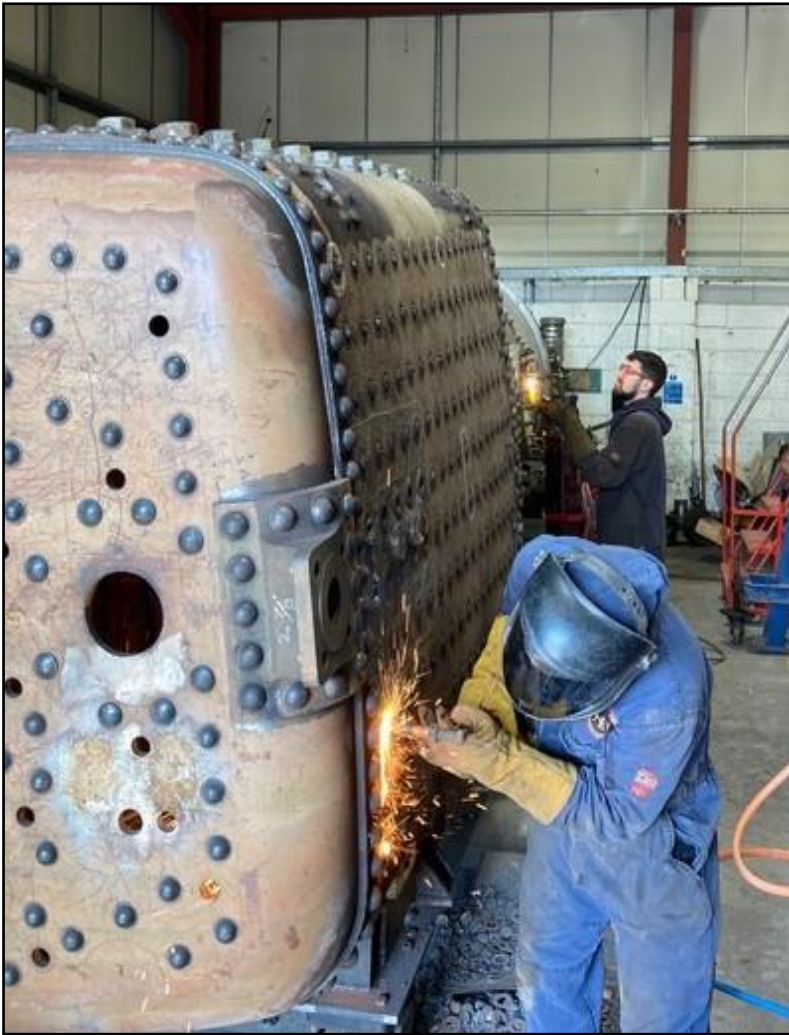
The guys at HBSS are seen here in action with the cutting torch, removing the many old crown stays which have all now been removed.

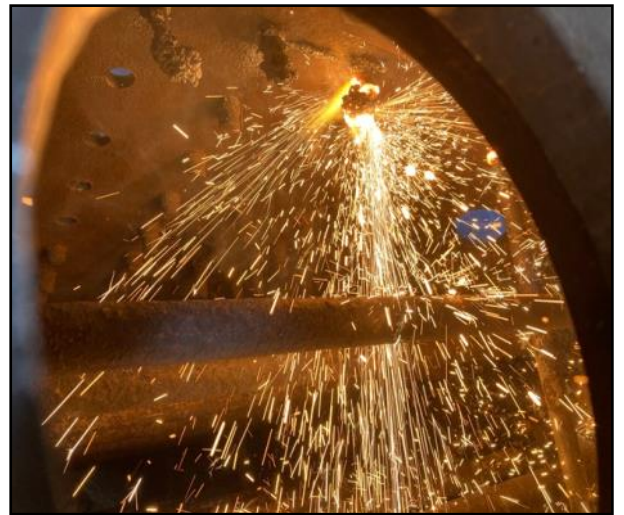
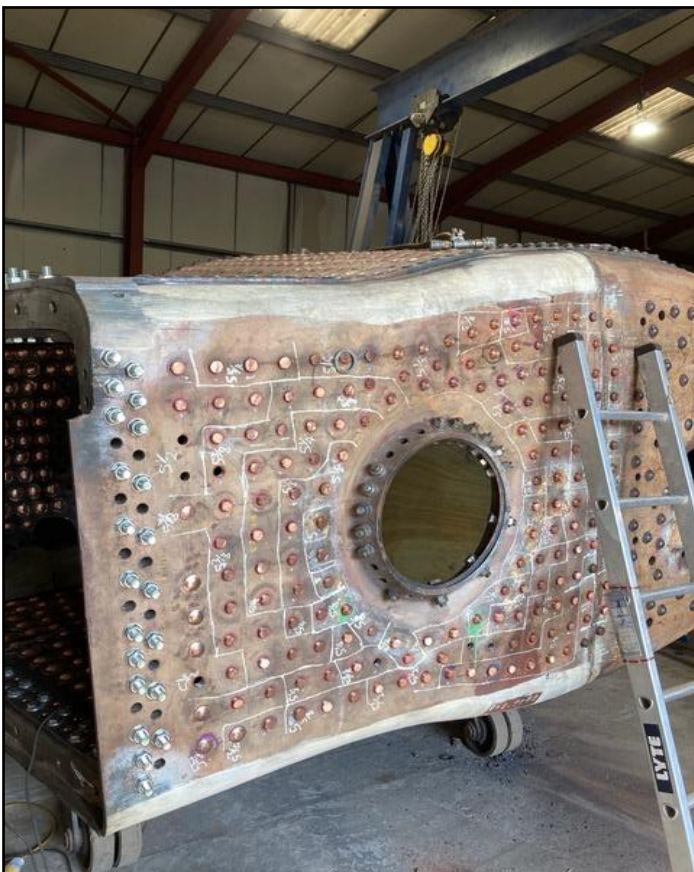
View through the firehole door, showing the inside of the firebox as the stays are removed.

We're not used to seeing the boiler in a horizontal position! But, the mere fact that it is on its side indicates that the pace has really picked up.

From this picture you can see that the foundation ring (*on the left of the picture*) is still in need of its rivets, together with the firedoor opening and a couple of stray ones in the backhead. Apart from the crown stays, that are being worked on as we speak, all other stays are now in place and knocked over.

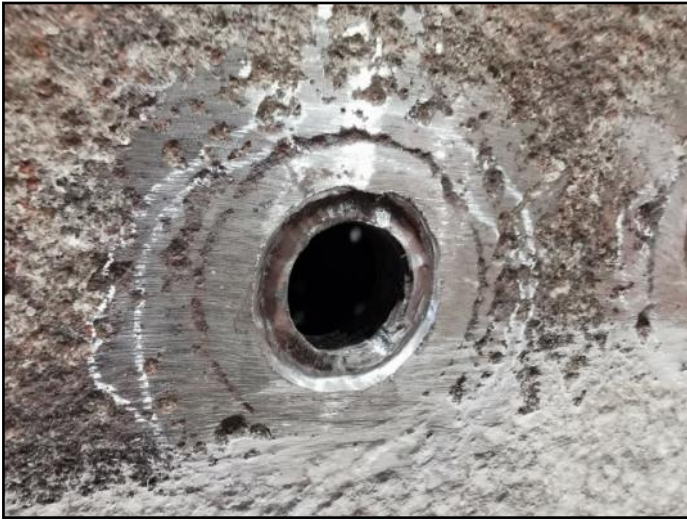
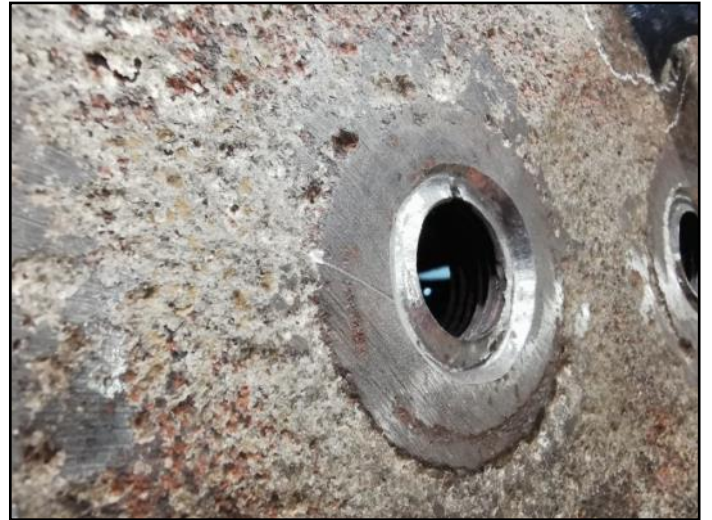
These two pictures (*above*), show an example of some of the crown stay holes that HBSS have had to weld to build up their surrounding edges. Where the boiler has been worked on and maintained over the years, the edges of the crown stay holes have been ‘caulked’ to make them watertight. Caulking is a process of chiselling the metal into and around the stays which, over the years, gradually wears away the metal surrounding the stay hole.

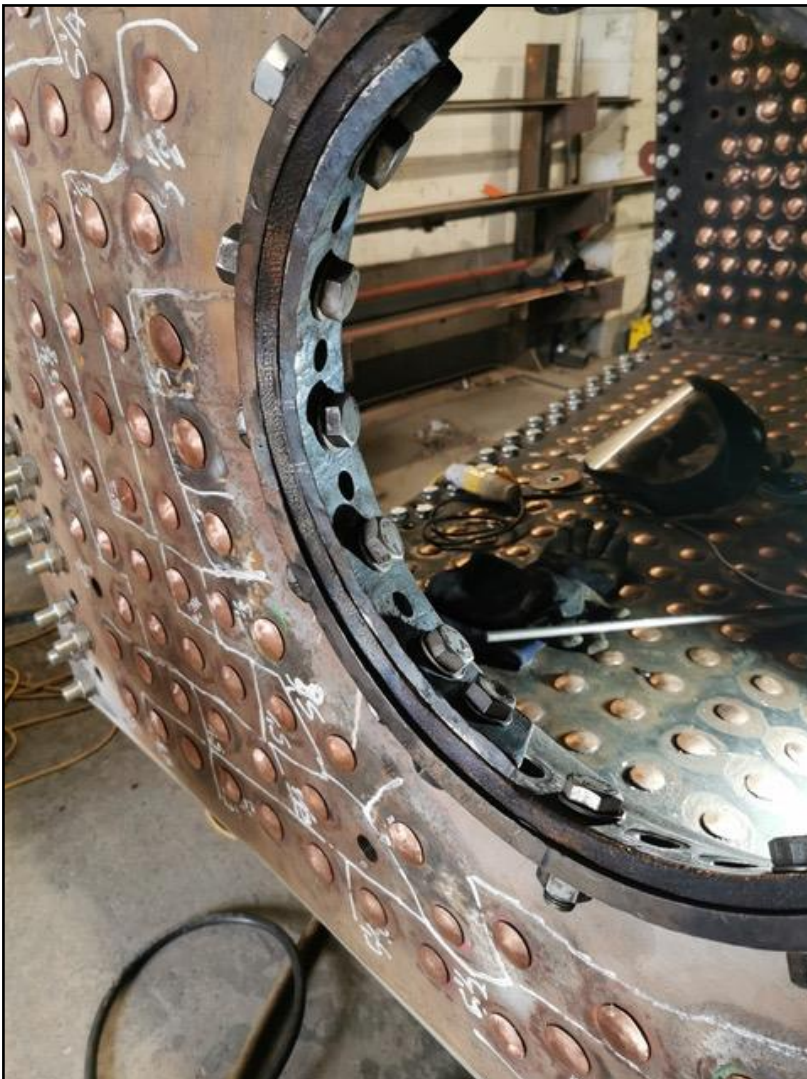
The picture (left), shows in detail the newly fitted ‘sacrificial wear plate’ which will eventually be riveted to the inner edge of the fire hole. This steel plate takes all the wear and tear when shovelling coal into the boiler and avoids the inner copper firebox edges getting damaged. It’s cheaper to put a new wear plate in than replace all or part of the copper firebox!

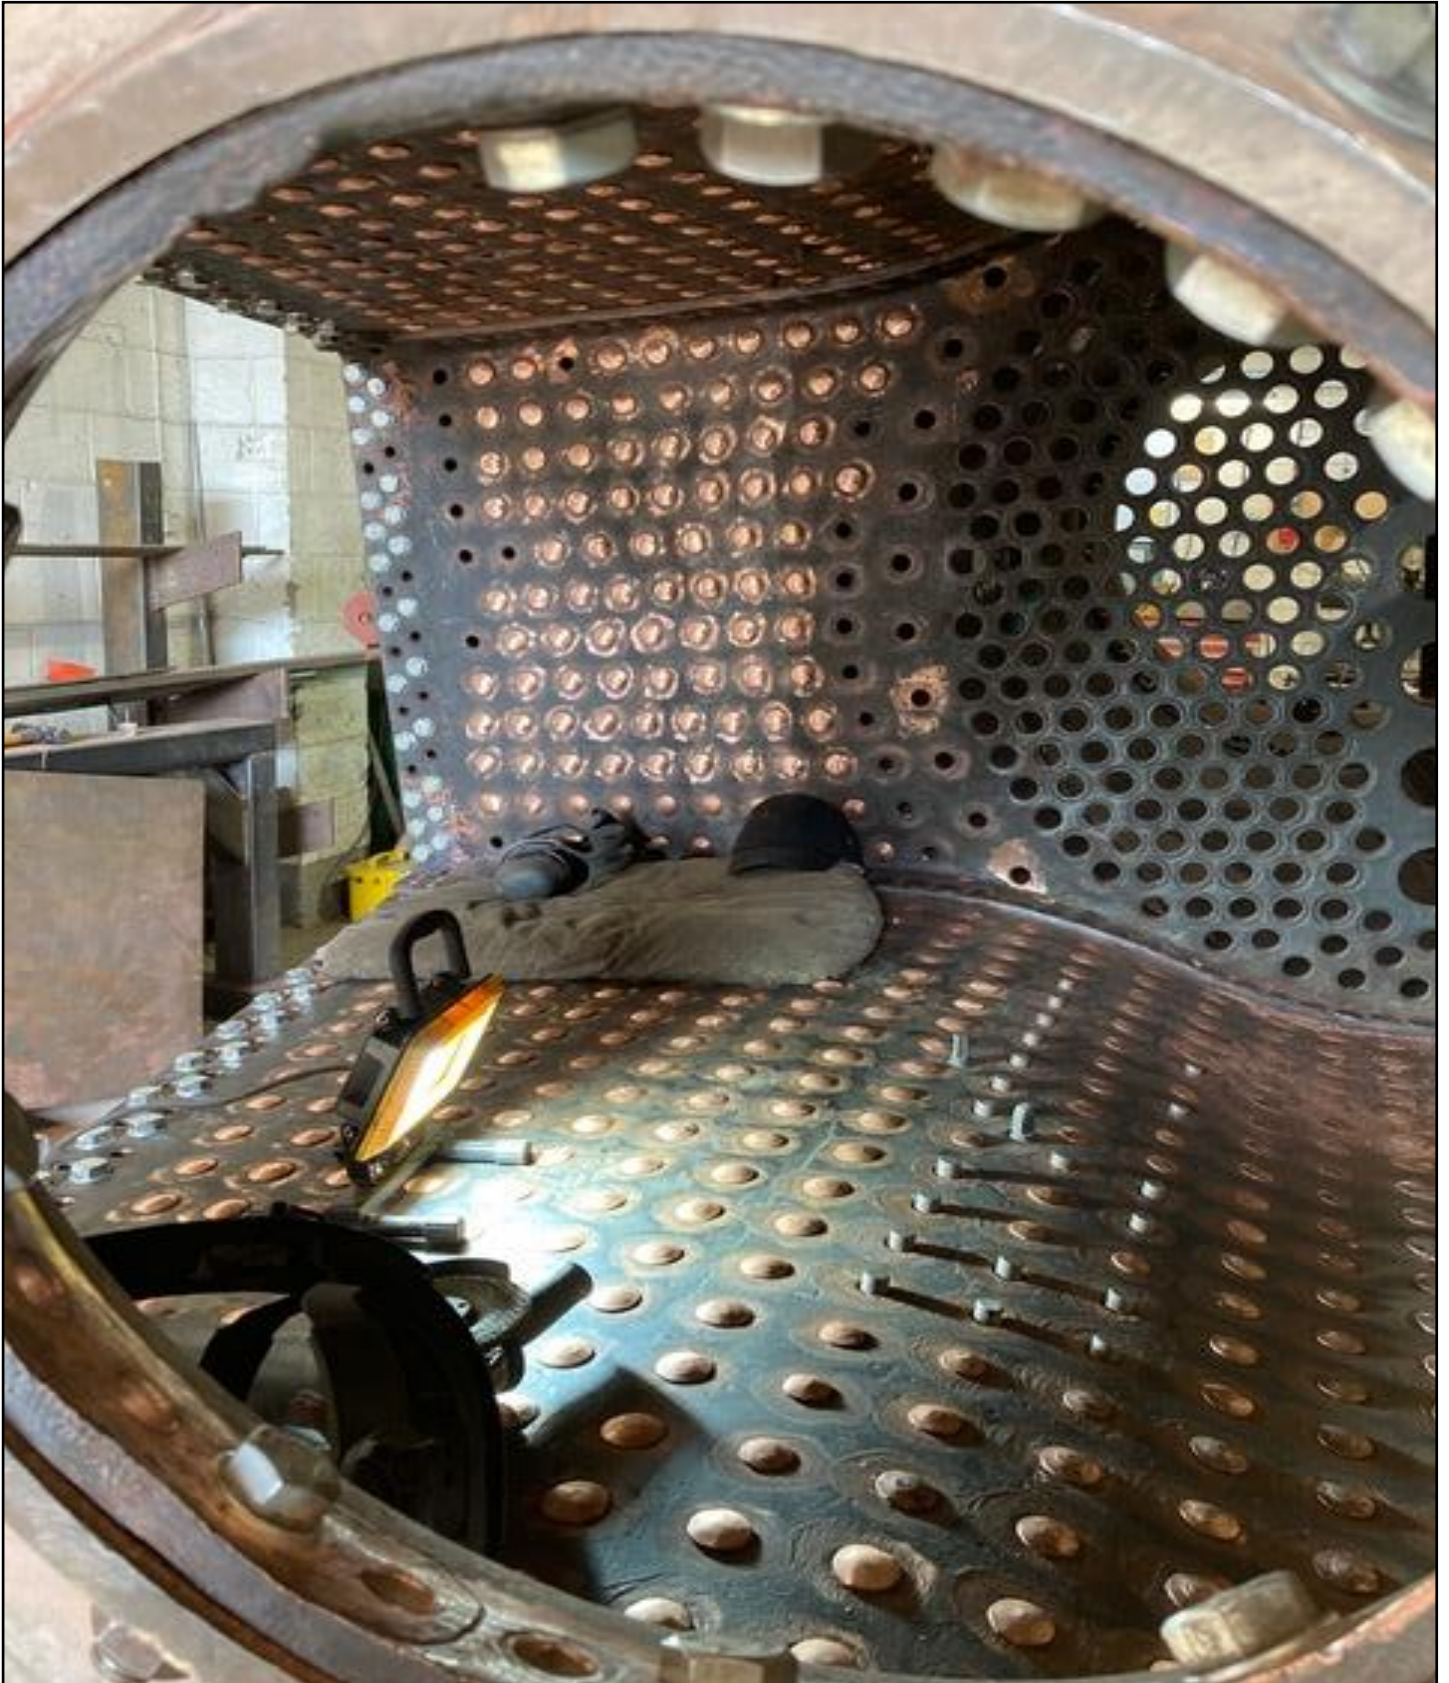
This rarely seen shot shows the inside of the firebox, through the firehole door. All the new shiny copper stays can be seen in place. To the right of the picture is the firebox tube plate that carries all the 235 fire tubes and 14 flue tubes forward through the main boiler water space and into the smokebox. To the left of the picture is where the grate and bed of coal sits, surrounded by the foundation ring which will carry the ashpan.

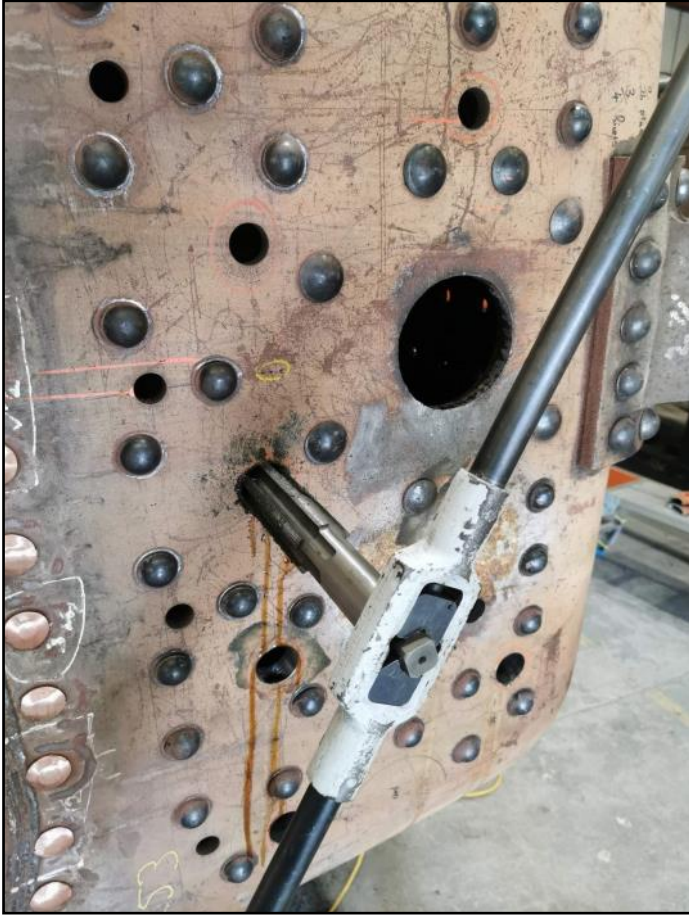
A very large and very expensive 'tap' being used at HBSS to thread a backhead hole, ready to screw in a longitudinal stay. This all has to be done by hand!

Along with everything else going on, preparatory work is being undertaken for installing the longitudinal stays. These run the length of the boiler from the backhead to the front tube plate and give boiler strength length-wise. Threads are being cut in the backplate to allow these stays to be screwed into position.

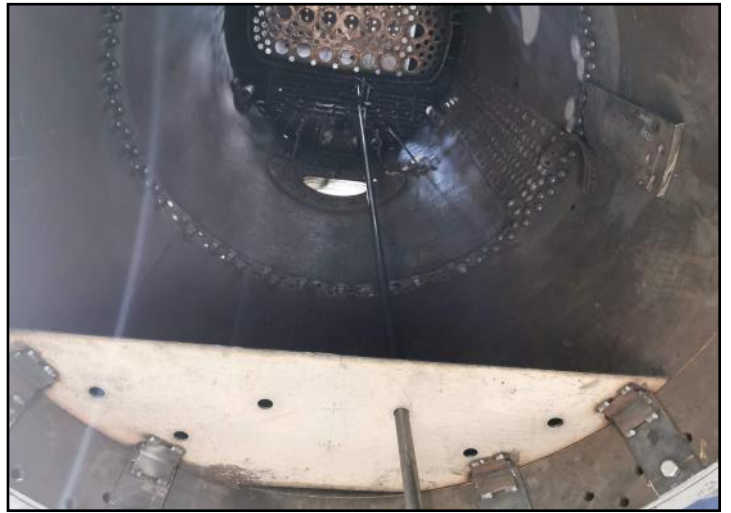
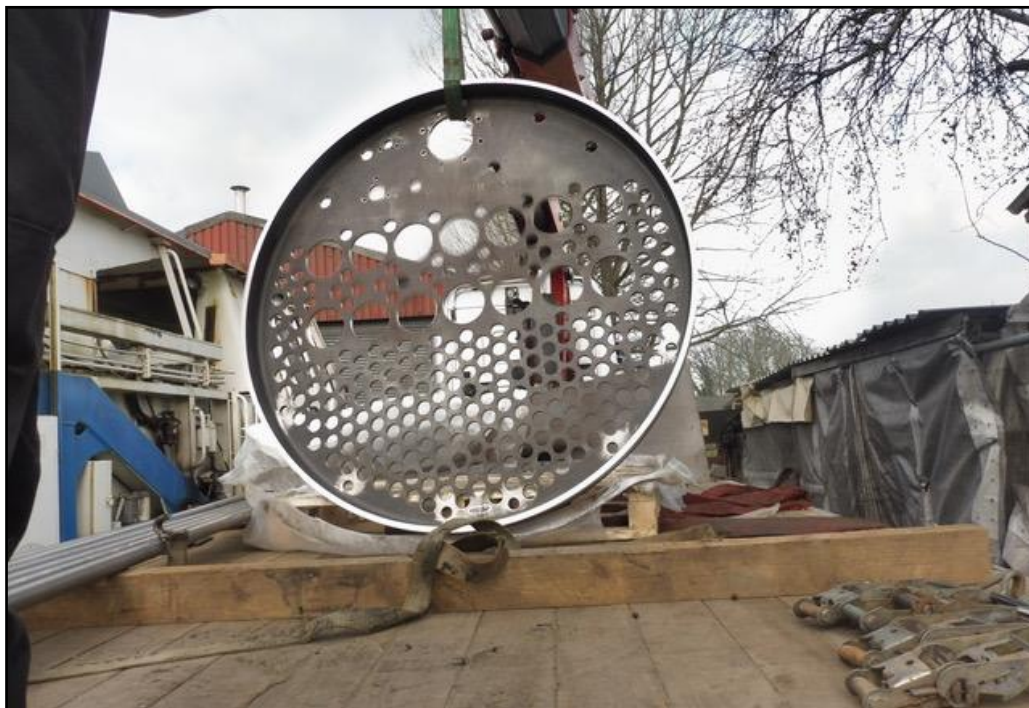
This shows the boiler barrel from the front end where the tube plate will go. A template has been temporarily fitted to enable alignment of the longitudinal stays, with a test bar shown in place.

The tube plate, which fits in the front end of the boiler barrel, carries the many tubes and longitudinal stays.

It's seen here being lifted on to a lorry for its trip to Liverpool.
