Newsletter

Issue 24

Winter 2024

The 4253 Locomotive Company Limited, based in Rolvenden, Kent, is a non-profit, non-political organisation. Reproduction of photos by permission of The 4253 Locomotive Company.

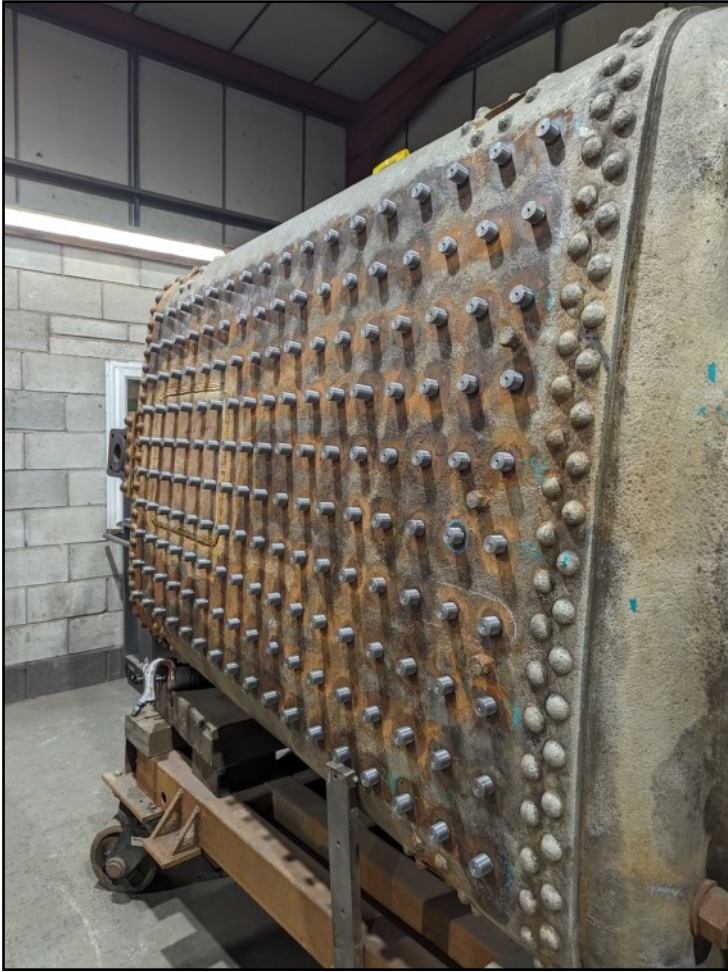
All the crown stays are now in place. This picture shows the top of the boiler (on its side) with the many rows of stays that had to be made especially for our boiler.

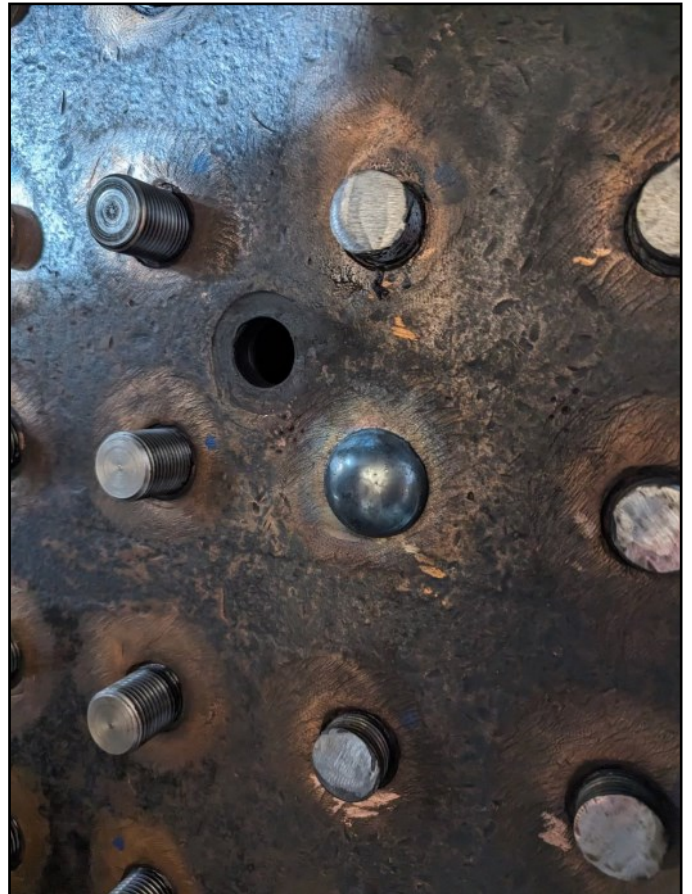
A close up of some of the stays, above, awaiting nuts and washers.

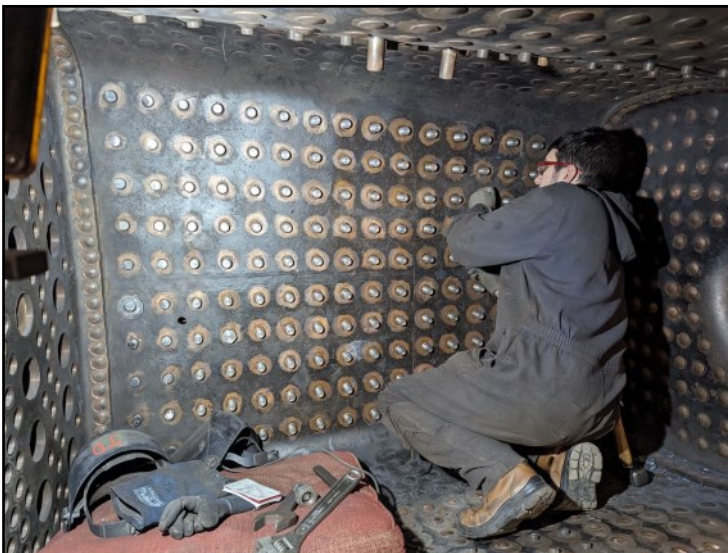
The picture left, shows Rob finishing the final crown stays inside the firebox.

In common with all the stays, they have a thread at each end. They have to first pass through the outer thread and then continue to screw into the inner thread at the other end.

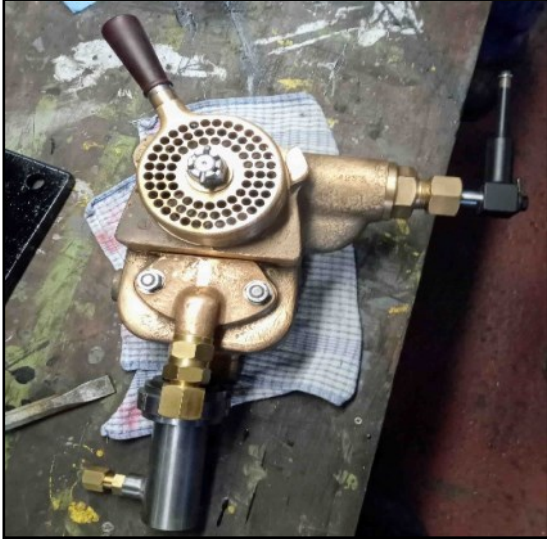
Vacuum Brake Ejector

For instance, in the cab we have the vacuum brake ejector; simply put, it applies or releases the brakes. The brakes are released by creating a vacuum of 25 inches (*maximum vacuum = 30 inches of mercury, but that's a whole different subject!*). By allowing the loss of this vacuum causes the brakes to be applied.

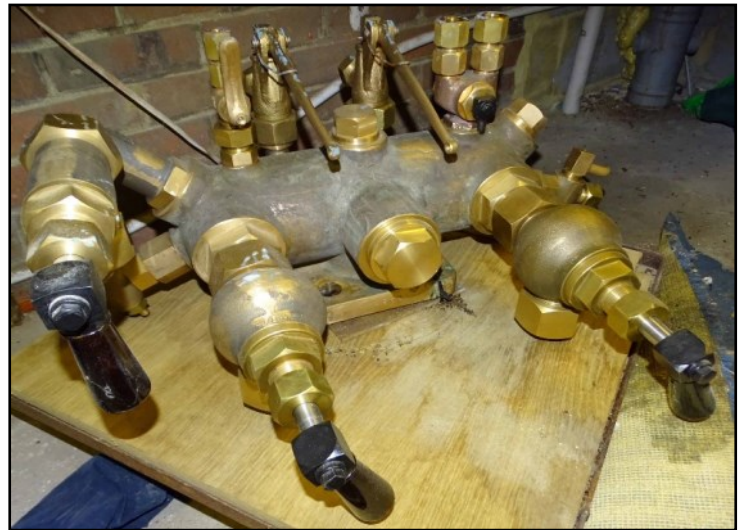
Steam Manifold

This impressive cluster of valves and levers are controls to many functions:

The top two 'levers' are attached to the locomotive's whistles. The valve on the left controls the steam to the Masons Valve, with the one bottom centre and the one to the right controlling the water to the boiler.

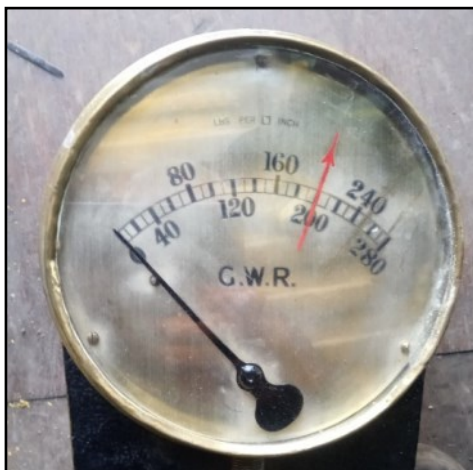
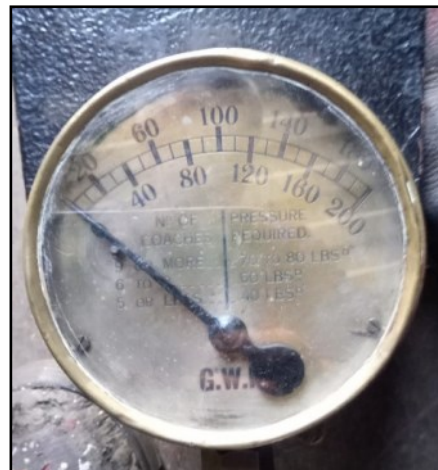
Also in the cab are various brass dials. The first is the boiler pressure gauge, showing the 200 psi (red arrow), needed to operate 4253 efficiently. The second is the steam heat pressure gauge, showing the steam pressure required depending on the number of carriages being pulled.

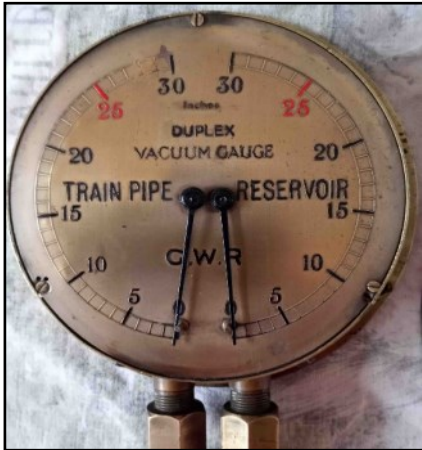
The third gauge (*below*) is the duplex brake gauge, which has two needle pointers.

The needle on the left indicates the amount of vacuum in the train pipe, which runs from the front to the back of the entire train as part of the vacuum braking system. Note the '25' in red, which is the amount of vacuum required to release the brakes, *as mentioned previously regarding the Vacuum Brake Ejector*.

When the brakes are applied, due to the train pipe having no vacuum, the left needle will drop to (or near) zero.

The pointer on the right shows the amount of vacuum available in the reservoir, ready to be used to release the brakes.

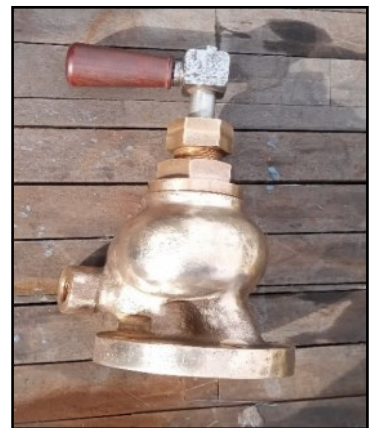
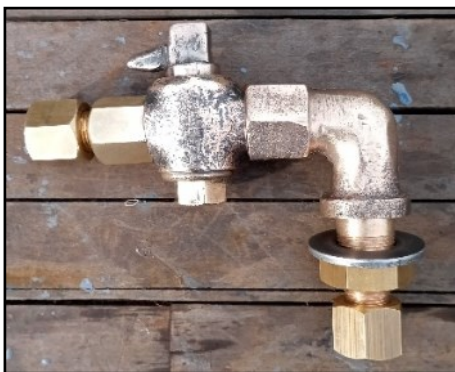
We also have a blower valve in the cab.

A blower ring is located in the smokebox and is used to create a 'venturi effect' causing a draft to flow from the bottom of the firebox, up through the fire itself, into the boiler tubes and then out of the chimney. This is used when the engine is 'coasting' or stationary to maintain the flow of air through the firebox when the engine is not working. It is operated in the cab by a turn on this blower valve.

The Jay Cock

This is connected to the hydrostatic lubricator system, which we looked at in an earlier article.

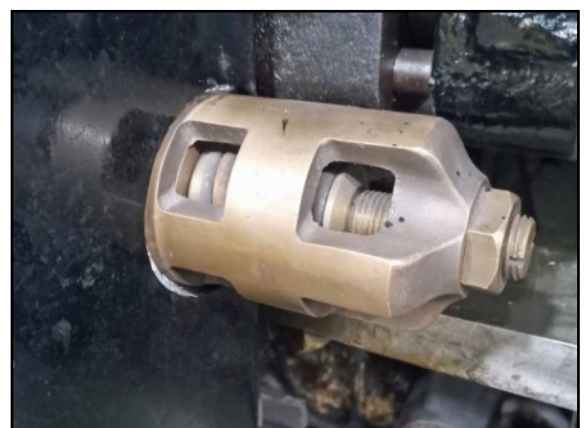
Cylinder Pressure Relief Valves

At each end of the piston cylinders we have the pressure relief valves. There are four of these, one for the back and front of each piston cylinder. They are there to prevent excess pressure buildup within the piston cylinder. They also allow ejection of any water (*that, as you will know, cannot be compressed*) to prevent damaging the pistons, rings or cylinder covers and seals.

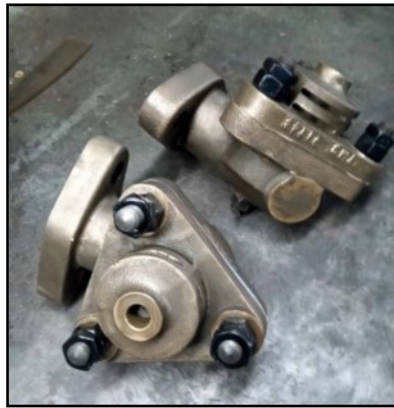
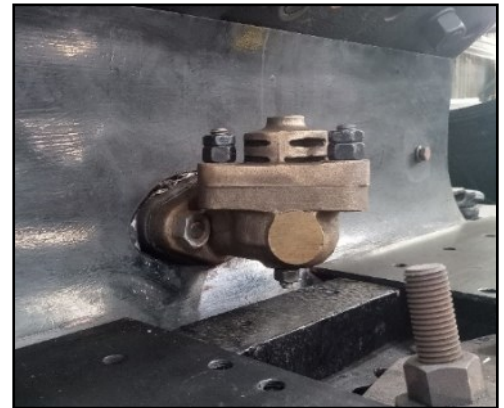
'Snifting' Valves

At the front of the locomotive are two snifting valves.

They are situated one on each side of the smokebox and are connected to the steam chest. These have a free moving piston inside them.

When steam is shut off to the cylinders while the locomotive is in motion and 'coasting', the moving pistons could create a partial vacuum in the cylinders. This would give rise to two problems.

Firstly, the pumping action would absorb energy and prevent the engine from coasting freely. Secondly, when the exhaust valve opens, soot and cinders from the smokebox could be sucked down the exhaust pipe and into the valve chest or cylinder, causing damage. (*The exhaust is open to the smokebox because in normal running the exhaust steam is sent through the blastpipe to draw the fire and eject the combustion products from the chimney*).

These problems are avoided by using snifting valves to allow air to be drawn into the cylinder when the locomotive is coasting. The 'snift' name comes from the sound they make while in operation, 'sniff', sniff, sniff" . . .

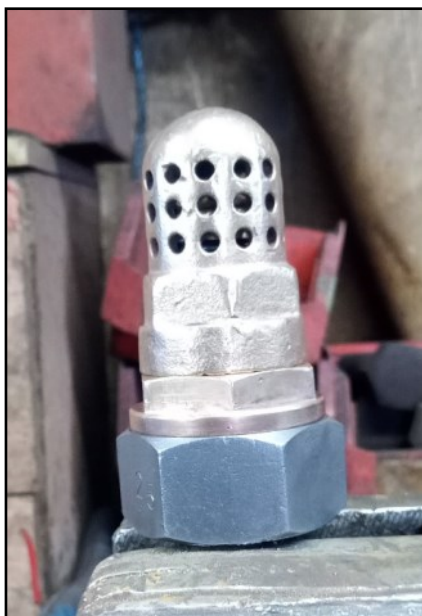
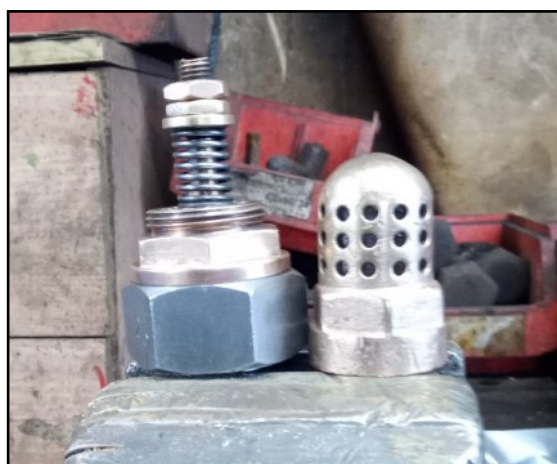
Hidden away out of sight within the frames are two very important brass bits; the Vacuum Relief Valves (or 'pepper pots', as they are known). They are set within the Vacuum Brake System, with one mounted on the vacuum pump and the other fitted to the train pipe. They are set to 25 inches of vacuum and prevent too much vacuum being created in the braking system.

A 'pepper pot' vacuum release valve complete (left), with the right-hand picture showing the inside of the valve.

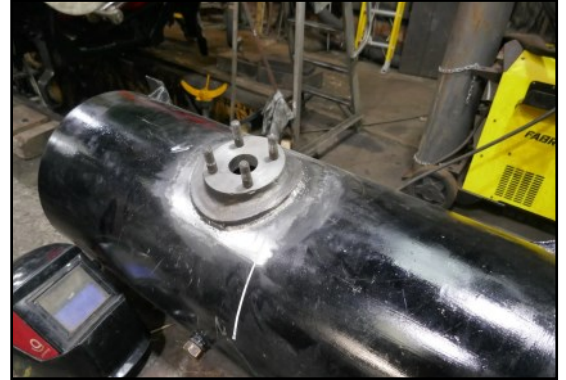
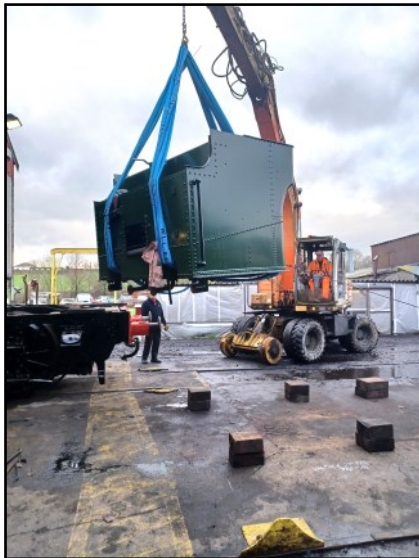
All the vacuum pipe sections, together with flanges and gaskets, were taken off the loco and bench tested under pressure. These tests revealed a number of deficiencies in both welds and gaskets.

In light of these partly foreseen discoveries, and after setting up a temporary vacuum test rig on the loco, we removed the vacuum reservoir tank for test, which sits directly under the cab floor and is normally inaccessible when the cab and floor is in place. Pressurising the tank independently revealed numerous pin-hole leaks in the tank itself and around the main vacuum pipe flange rivets. After many hours trying to make the tank airtight, we reluctantly gave up and ordered a new one to be made. This was more money that had not been anticipated, but given its normally inaccessible position underneath the loco and its importance to the braking system, it had to be totally sound and 'bomb proof'. We wouldn't get another chance when the floor and cab were back in place, as the tank can only be removed upwards out of the frames!

Having received (*and at lightening speed*) the new custom made tank components, it was welded together along with a newly cast pipe flange (*above right*). It passed its vacuum test with flying colours. So far so good.

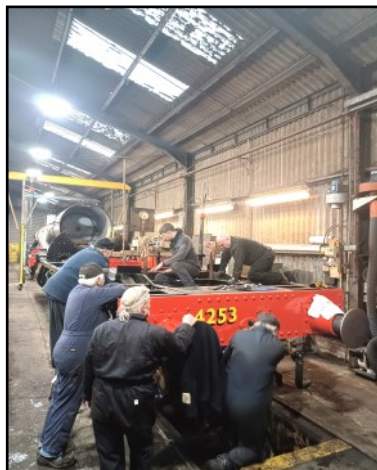
The only item left to test in the whole system was the large main brake cylinder which sits between the frames under the bunker and yes, you've guessed it, the cylinder can only be removed upwards! We seemed to be going backwards with all of this but everything has got to be right, so off came the bunker once again (*left*), and we removed the cylinder for inspection. Not only was it found that the inner surface was pitted in places, but we also found a hairline crack in the side wall, something that had not been spotted when the cylinder was put in some years ago. As we write, a new cylinder has been ordered and once put back together and tested we should hopefully, at last, have a sound and fully functioning braking system.

Volunteers swarm over the loco trying to get a glimpse of the brake cylinder, just before it is removed for testing and eventual replacement.

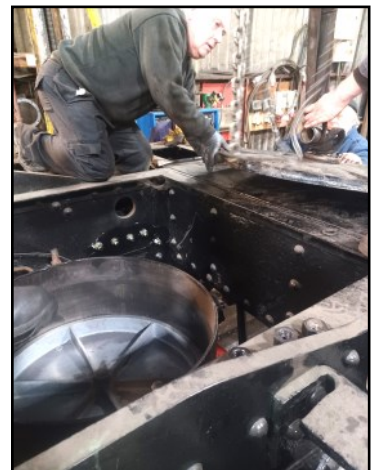
The faulty brake cylinder can be seen sitting in between the frames. The cylinder has a top 'lid' which has been removed to reveal the piston beneath.
